Asset Care Counts #4

UNIQUE APPLICATION OF CONVENTIONAL RADIOGRAPHY

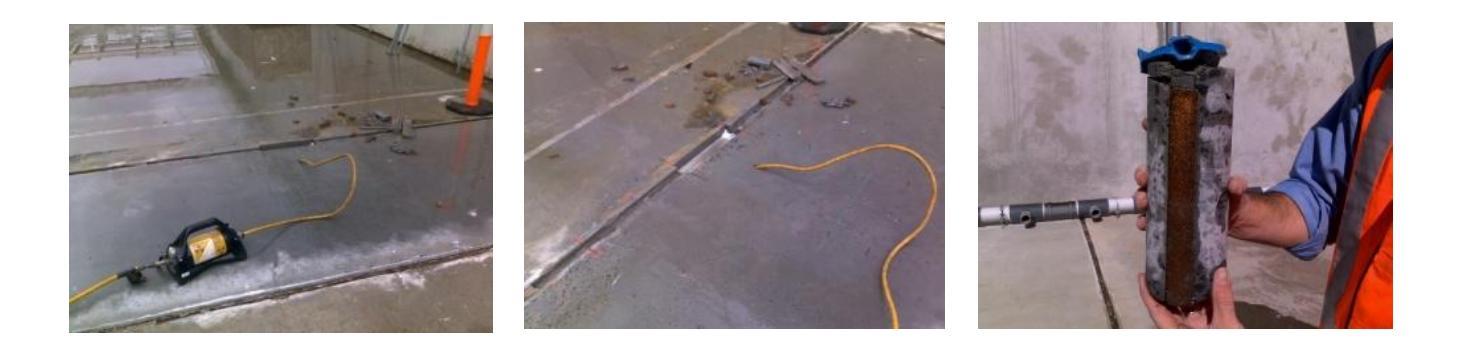
The inspection was a great success. Radiographic images clearly identified the joints were not as per the specification. Concrete had flowed under the water stop membrane and over the top of the cork fill resulting in significant cracking. Subsequent core samples that were removed from selected "worst case" areas confirmed our findings.

Photographs clearly show the set up of the radiographic isotope and the position of the film, as well as a core sample confirming the ALS results.
