Asset Care Counts

Risk Based Inspection of Aging Water Pipe Work

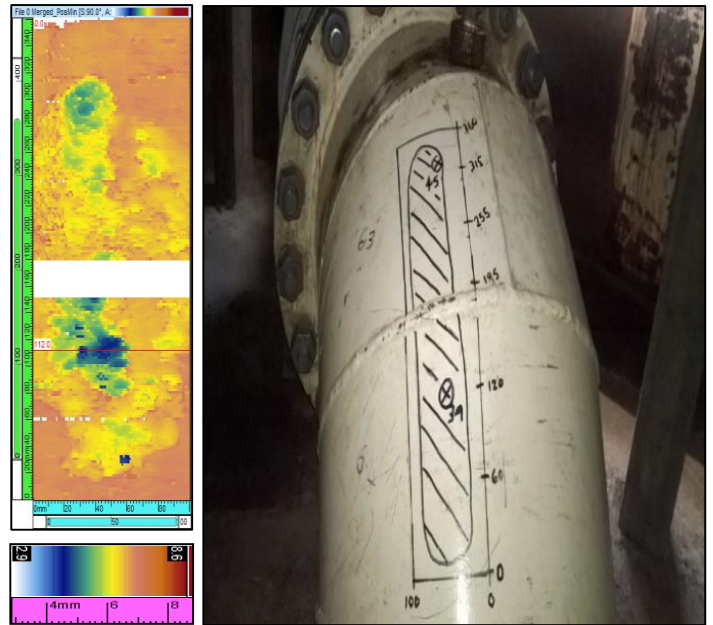
Figure 2 – Corrosion Mapping in MSCL Piping

The inspection program used a variety of NDT techniques designed to supplement each other and provide a high likelihood of detection (LOD) of the damage mechanisms. Techniques included:

- SLOFEC Pipe Inspection for rapid scanning of long lengths of piping.
- Phased Array Ultrasonic Testing (PAUT) of wall thickness
- Ultrasonic thickness grid surveys and spot readings.
- Thermography.
