Peterbilt 89e Diesel Engine

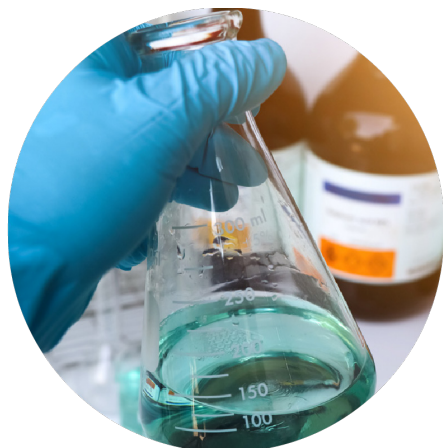
A problem with a diesel engine was recently discovered. Laboratory results indicated that a coolant leak was present and immediate action was needed to save the equipment.

The spectrochemical analysis showed high concentrations of sodium and potassium, both prominent additives engine coolants. The copper, tin and lead levels were also elevated indicating possible damage to engine components. Additional tests showed that glycol and water were present in the lubricant.

Corresponding analytical results showed a high concentration of sodium and potassium (coolant additives), as well as the excessive wear metal concentrations (lead, copper, and tin). This sample tested positive for coolant and had a large amount of free water in the sample. The water contamination prevented an accurate viscosity to be performed.

The customer was notified immediately upon completion of the testing. The unit was pulled from service and the coolant leak was identified. Upon inspection the mechanic found a thickened gel type material on the valve covers of this engine. Damage was observed to the connecting rod bearings and the cylinder linings. The source of the engine coolant leak was discovered and repaired. Additional damage to the connecting rod bearings were made.

Coolant contamination can cause bearing problems, especially in copper-lead and bronze-lead bearings as well as poor lubrication and increased corrosion. Coolant contamination may also react and cause an increase in sludge and other degradation products. Without detection engine repairs would have cost an additional \$4,000 at a minimum.
